**Flood Control Project Maintenance
Levee Inspections****LMA District Cover Sheet
Spring 2015 Levee Inspection Results****Reclamation District No. 0554 Walnut Grove**

Levee Inspection Report By Mile - Spring 2015

Reclamation District No. 0554 Walnut Grove

Waterway	Bank	Unit Miles	Inspection Start/End	Inspector
Unit No. 01 Sacramento River	Left	1.13	04/29/2015 04/29/2015	Herman Phillips

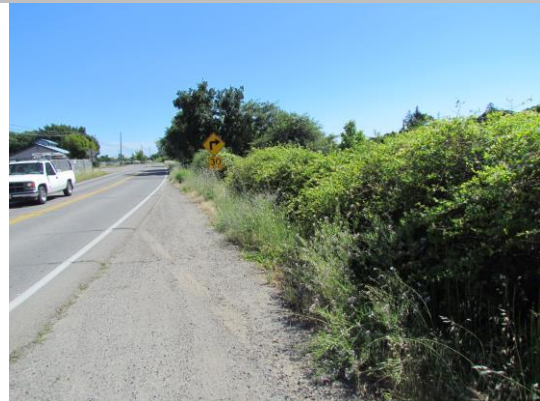
Photo 1 of 1 : SP_2015_RD0554_176_127_20150603_00139.jpg

LM Start	0.03	Rating **	U	Issue No.	127
LM End	0.13	Issue Type +	Ma	Location *	WS
Category	Earthen Levee			GPS Latitude/Longitude	
				Start	End
Item	Vegetation			38.249393 °	38.247823 °
				-121.510040 °	-121.509945 °
DWR ID	DWR_RD0554_01_s_2015_127				
Action/Comments					
Remove the wild growth other than native grasses from the levee slopes.

View looking downstream from the waterside shoulder.

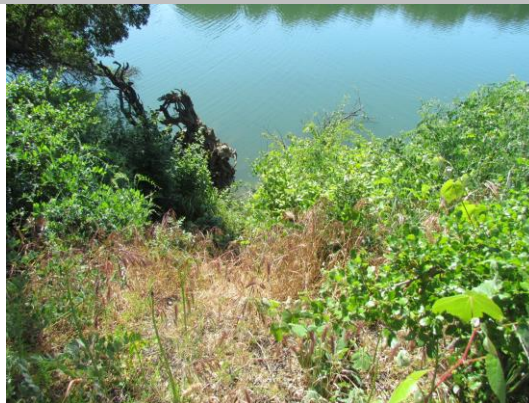
Photo 1 of 1 : SP_2015_RD0554_176_11_20150603_00138.jpg

LM Start	0.10	Rating **	U	Issue No.	11
LM End	0.10	Issue Type +	Ma	Location *	WS
Category	Earthen Levee			GPS Latitude/Longitude	
				Start	End
Item	Erosion / Bank Caving			38.248262 °	38.248262 °
				-121.509901 °	-121.509901 °
DWR ID	DWR_RD0554_01_s _ 2014_11				
Action/Comments					
Note and monitor erosion site. Inspector Comments: This is not a new erosion site, repairs are needed. One tree has fallen into the Sacramento River at the erosion site.

Erosion on waterside toe.

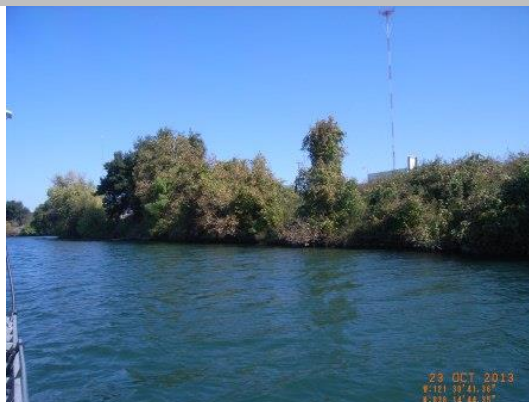
Photo 1 of 2 : SP_2015_RD0554_176_2_20150312_00001.jpg

LM Start	0.26	Rating **	M	Issue No.	2
LM End	0.36	Issue Type +	Ma	Location *	WS
Category	Supplemental			GPS Latitude/Longitude	
				Start	End
Item	USACE Erosion Survey			38.246222 °	38.245017 °
				-121.510878 °	-121.511740 °
DWR ID	DWR_RD0554_01 f_2014_2

Action/Comments					
Inspector Comments: 2009 - Tension cracks on road on top of levee. Erosion into the levee slope and mass failure. 2013: Short vertical sections at bank toe. [2013 Site ID: SAC_27-0_L]

USACE 2013 Photo #1

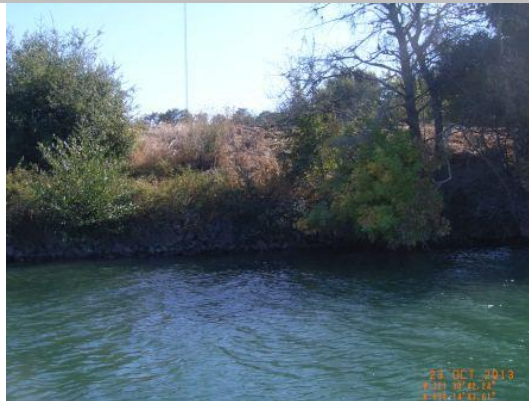
Photo 2 of 2 : SP_2015_RD0554_176_2_20150312_00002.jpg

LM Start	0.26	Rating **	M	Issue No.	2 (cont)	
LM End	0.36	Issue Type +	Ma	Location *	WS	
Category	Supplemental			GPS Latitude/Longitude		
				Start	End	
Item	USACE Erosion Survey			38.246222 °	38.245017 °	
				-121.510878 °	-121.511740 °	
DWR ID	DWR_RD0554_01_f_2014_2					
Action/Comments						
Inspector Comments: 2009 - Tension cracks on road on top of levee. Erosion into the levee slope and mass failure. 2013: Short vertical sections at bank toe. [2013 Site ID: SAC_27-0_L]

USACE 2013 Photo #2

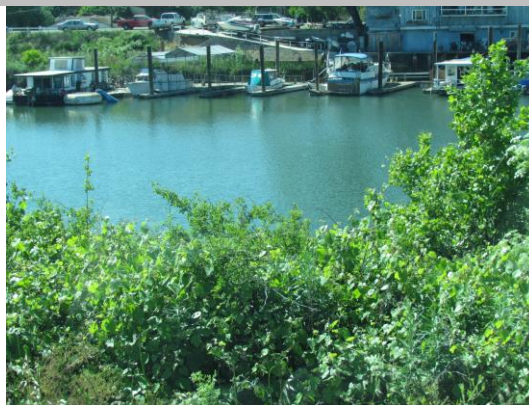
Photo 1 of 1 : SP_2015_RD0554_176_132_20150603_00140.jpg

LM Start	0.29	Rating **	U	Issue No.	132
LM End	0.32	Issue Type +	Ma	Location *	WS
Category	Earthen Levee			GPS Latitude/Longitude	
				Start	End
Item	Vegetation			38.245737 °	38.245438 °
				-121.511025 °	-121.511225 °
DWR ID	DWR_RD0554_01_s_2015_132				
Action/Comments					
Remove the wild growth other than native grasses from the levee slopes.					
Inspector Comments: Remove the vegetation from the slope.

Looking downstream waterside slope.

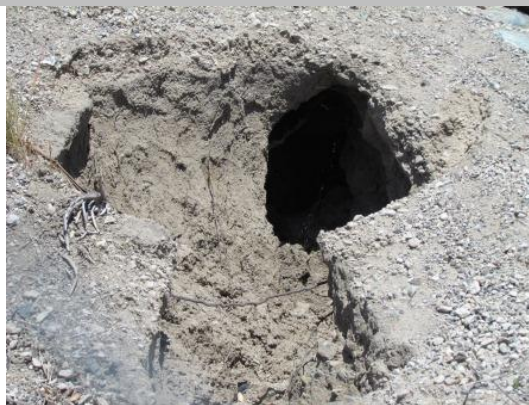
Photo 1 of 2 : SP_2015_RD0554_176_13_20150312_00006.jpg

LM Start	0.32	Rating **	U	Issue No.	13
LM End	0.32	Issue Type +	Ma	Location *	N/A
Category	Earthen Levee			GPS Latitude/Longitude	
				Start	End
Item	Erosion / Bank Caving			38.245389 °	38.245389 °
				-121.511085 °	-121.511085 °
DWR ID	DWR_RD0554_01_s_2014_13

Bank caving along the landward levee slope.

Action/Comments					
Schedule repair of erosion site prior to the next inspection. Inspector Comments: This erosion along the slope need to be repaired before rainy season.

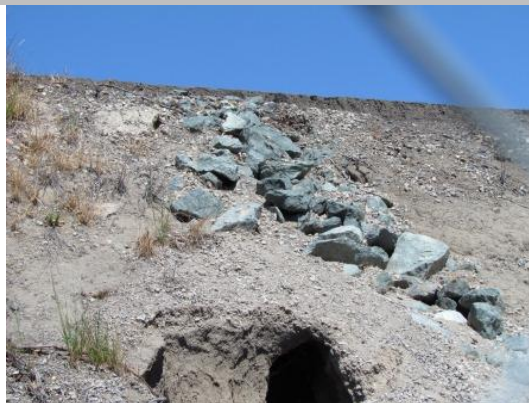
Photo 2 of 2 : SP_2015_RD0554_176_13_20150312_00007.jpg

LM Start	0.32	Rating **	U	Issue No.	13 (cont)	
LM End	0.32	Issue Type +	Ma	Location *	N/A	
Category	Earthen Levee			GPS Latitude/Longitude		
				Start	End	
Item	Erosion / Bank Caving			38.245389 °	38.245389 °	
				-121.511085 °	-121.511085 °	
DWR ID	DWR_RD0554_01_s_2014_13					
Action/Comments						
Schedule repair of erosion site prior to the next inspection. Inspector Comments: This erosion along the slope need to be repaired before rainy season.

Another view of the issue.

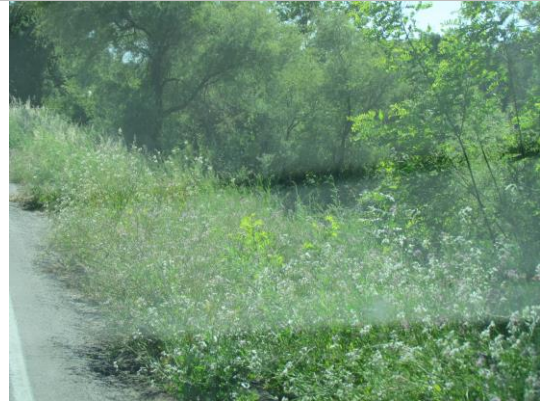
Photo 1 of 1 : SP_2015_RD0554_176_134_20150603_00141.jpg

LM Start	0.77	Rating **	U	Issue No.	134
LM End	0.84	Issue Type +	Ma	Location *	WS
Category	Earthen Levee			GPS Latitude/Longitude	
				Start	End
Item	Vegetation			38.240033 °	38.239227 °
				-121.515998 °	-121.516745 °
DWR ID	DWR_RD0554_01_s _ 2015_134				
Action/Comments					
Control annual grass and weeds on the levee slopes and easements. Inspector Comments: Control the unacceptable weeds on the waterside slope.

View looking downstream at the waterside slope.

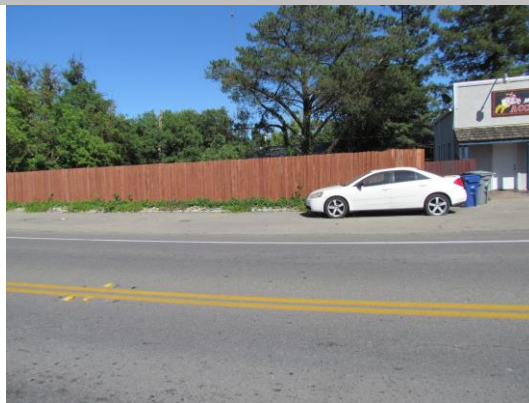
Photo 1 of 1 : SP_2015_RD0554_176_1_20150603_00142.jpg

LM Start	0.89	Rating **	U	Issue No.	1
LM End	0.89	Issue Type +	En	Location *	LS
Category	Earthen Levee			GPS Latitude/Longitude	
				Start	End
Item	Encroachments			38.238326 °	38.238326 °
				-121.516940 °	-121.516940 °
DWR ID	DWR_RD0554_01_s_2015_1				
Action/Comments					
Fence					
Inspector Comments: No permit for this encroachment.

Unauthorized wooden fence on the landside shoulder.

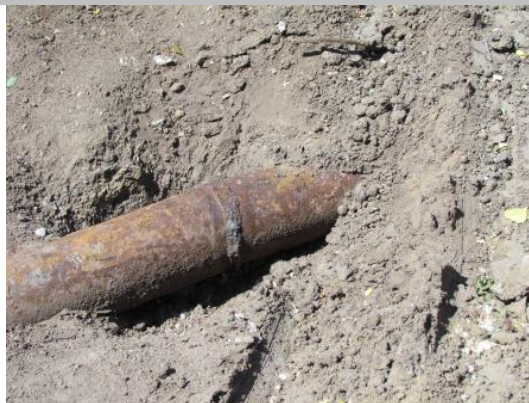
Photo 1 of 3 : SP_2015_RD0554_176_16_20150312_00008.jpg

LM Start	1.11	Rating **	U	Issue No.	16
LM End	1.11	Issue Type +	En	Location *	N/A
Category	Earthen Levee			GPS Latitude/Longitude	
				Start	End
Item	Encroachments			38.235422 °	38.235422 °
				-121.517233 °	-121.517233 °
DWR ID	DWR_RD0554_01_s_2014_16				
Action/Comments					
Pipe Inspector Comments: Unauthorized pipe repair done without CVFPB permit.

Uncovered pipe section on the landward toe levee mile 1.09. Photo taken 06-05-2014.

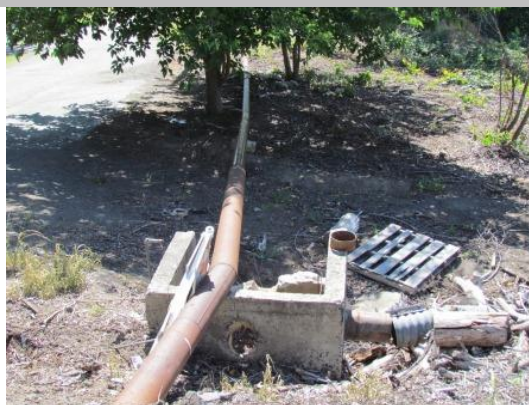
Photo 2 of 3 : SP_2015_RD0554_176_16_20150312_00009.jpg

Another view of the unauthorized pipe repair viewed from landside shoulder. 06-05-2014.

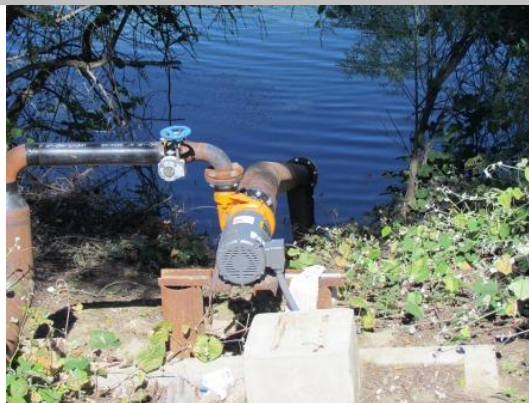
Photo 3 of 3 : SP_2015_RD0554_176_16_20150312_00010.jpg

Waterside view of the unauthorized pipe repair, new pump shown in picture. Photo taken 06-05-2014.
